Manhole Inspection Summary

Manhole # S15CC1008MH

Location Address: **3820 PALL MALL RD**

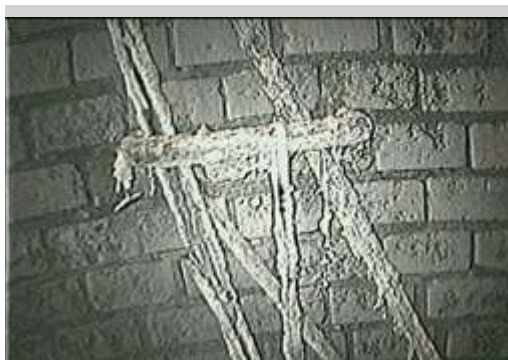
Evidence of surcharge - Bench debris.
Corroded steps.

Evidence of surcharge

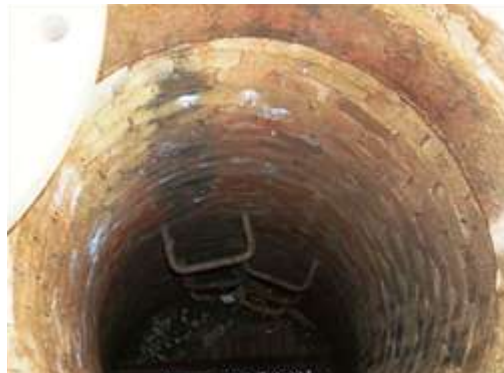
Defect

Frame leaks. Adjustment deterioration
and loose brick. Adjustment and Barrel
infiltration - other side.

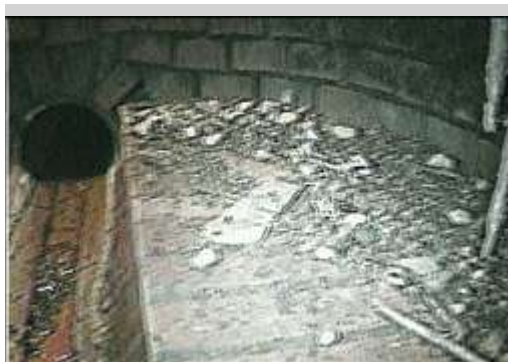
Defect

Bench debris.

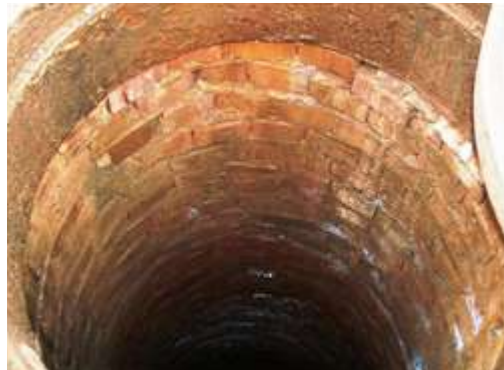
Defect

Frame leaks. Adjustment deterioration
and loose brick. Adjustment and Barrel
infiltration.

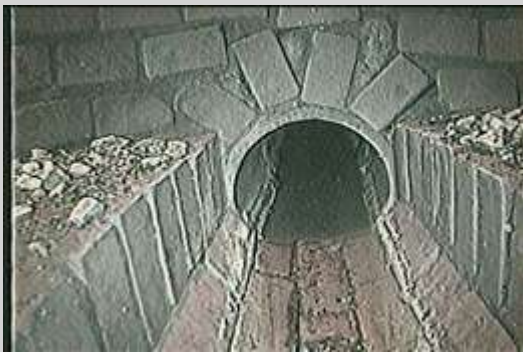
8 in. Circular Gravity Sewer Pipe Out @ 12 O'Clock

Deposits: ☐ None ☐ Mud ☐ Sludge ☐ Debris ☒ **Grease**

Silt Depth: **0** (in.) Deposits Extent: **Light**

Infiltration: **Evidence** Pipe Seal Cond: **Unknown**

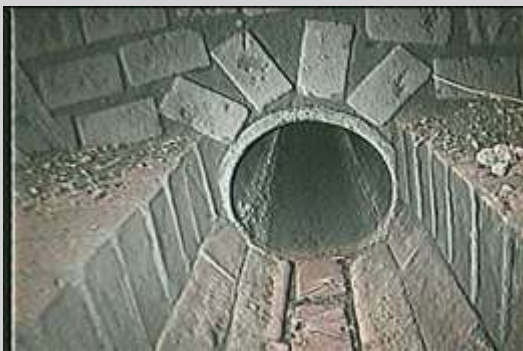
8 in. Circular Gravity Sewer Pipe In @ 6 O'Clock

Deposits: ☐ None ☐ Mud ☐ Sludge ☐ Debris ☒ **Grease**

Silt Depth: **0** (in.) Deposits Extent: **Light**
